CENTRAL VALLEY REGIONAL WATER QUALITY CONTROL BOARD

INSPECTION REPORT

LOCATION & COUNTY: Henry Tosta Dairy
20662 San Jose Road, Tracy
San Joaquin County

INSPECTION DATE: 10 October 2012

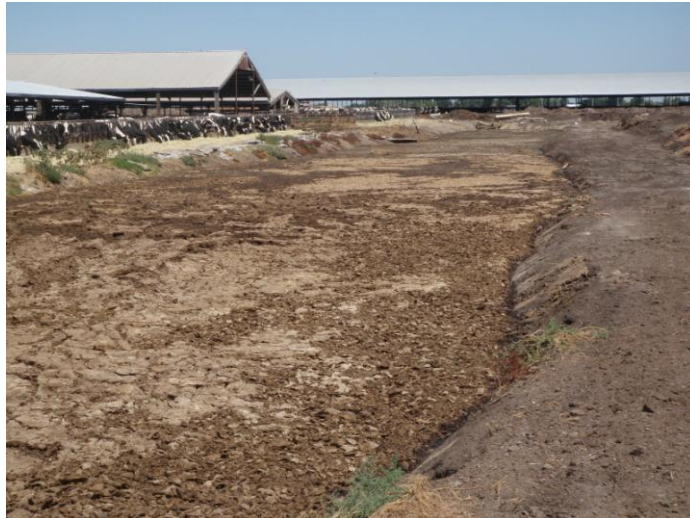
On 26 July 2012 staff observed 2'-4' of freeboard at Settling Basin #1 (Photo 1). On 5 September 2012 staff observed zero (0) freeboard at Settling Basin #1 (Photo 2). On 10 October 2012 staff observed wastewater over-topping the southern / northern embankments and adjacent dirt access road at Settling Basin #1 (Photos 3-5). Prior to the 1 May 2012 compliance inspection wastewater and solid manure were conveyed directly to the 3-4 acre area of native soil; currently wastewater and solid manure are conveyed to Settling Basin #1 thus why Settling Basin #1 is not contained / over-topping.

Photo 1 taken 26 July 2012: Settling Basin #1 with 2'-3' freeboard.

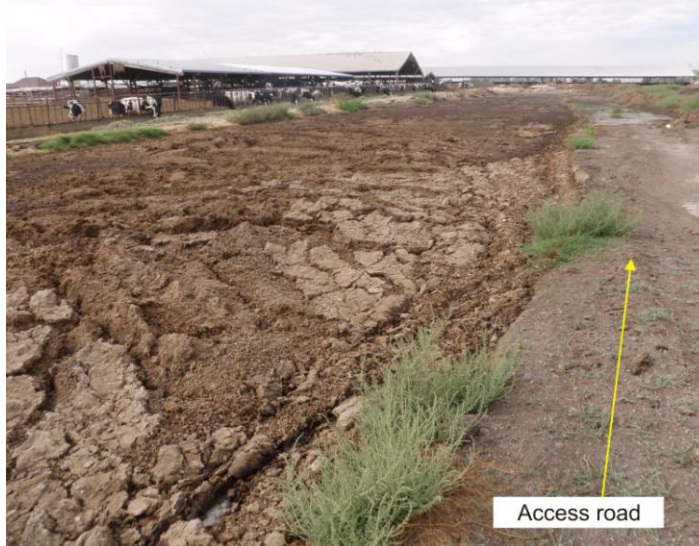
Photo 2 taken 5 September 2012: Settling Basin #1 with 0.5'-1' freeboard.

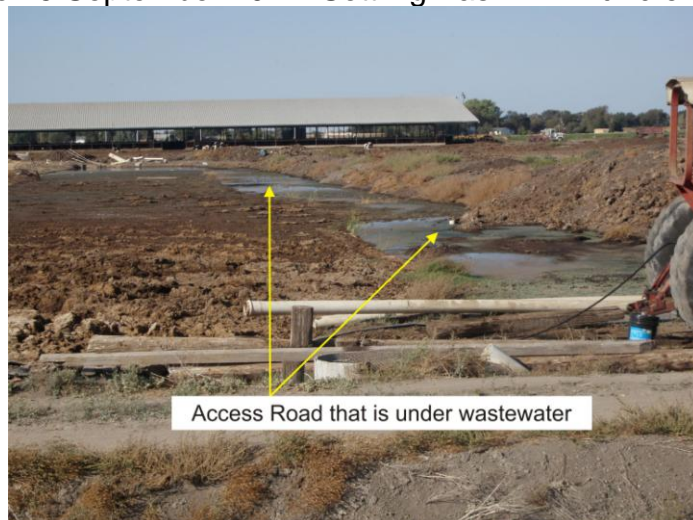
Settling Basin #1 has no fixed pump to convey wastewater to any other settling basins or lagoons; a PTO pump is currently being used to attempt to pump the wastewater from Settling Basin #1 to Settling Basin #2 but appears to not have the power to convey the volume of wastewater that is being generated by the ongoing dairy operations. Additionally Settling Basin #1 is immediately adjacent to the Naglee-Burk Irrigation Canal; it appears to staff that there's potential for Settling Basin #1 to discharge wastewater directly to the canal which conveys water to the Old River which is a tributary of the San Joaquin River.

Photo 3 taken 10 October 2012: Settling Basin #1 with wastewater over-topping the southern / northern embankments and dirt access road.

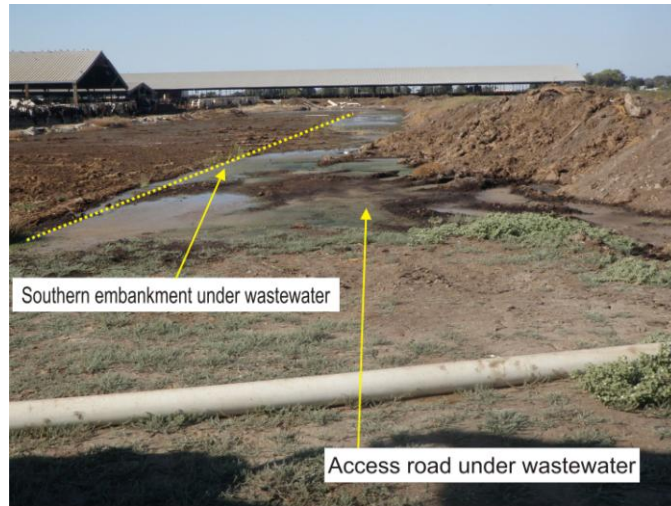
Photo 4 taken 10 October 2012: Settling Basin #1 with wastewater over-topping the southern / northern embankments and dirt access road.

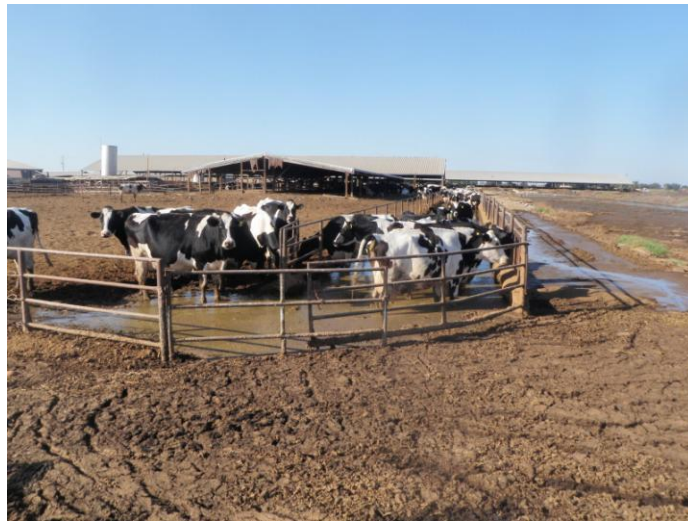
Photo 5 taken 10 October 2012: Settling Basin #1 is seen in the right-hand portion of the photo; the wastewater from the basin is backing up into the feed lane and corral.

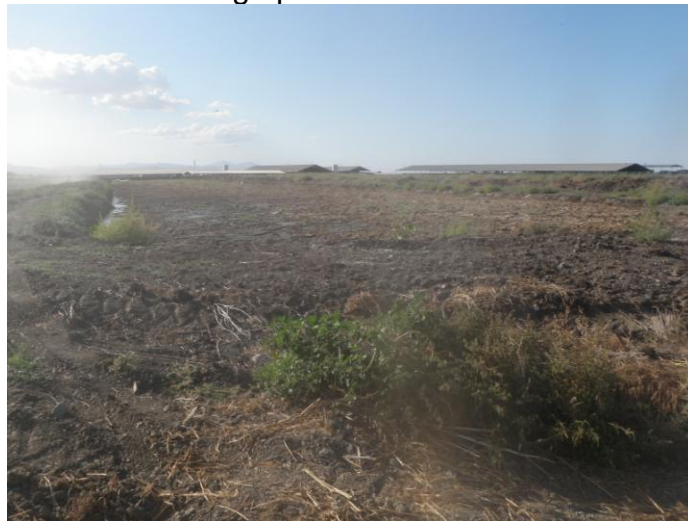
Settling Basin #2 had 2'-3' freeboard with a significant amount of solid manure in the basin (Photo 6).

Photo 6 taken 10 October 2012: Settling Basin #2 with 2'-3' freeboard and significant amount of solid manure.

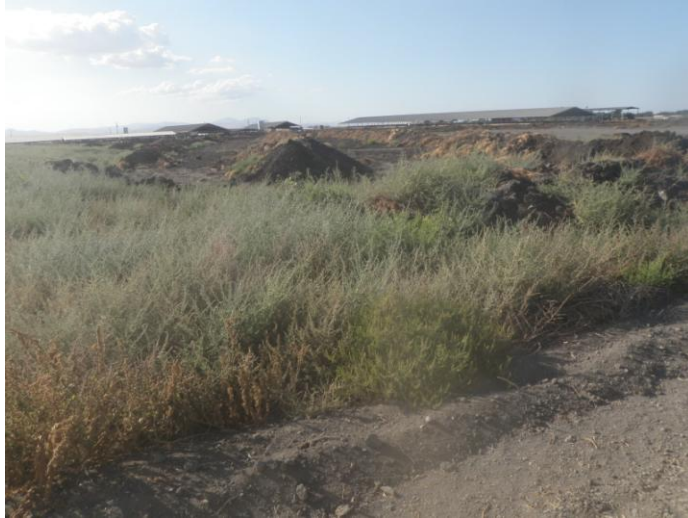
Wastewater Storage Lagoon #1 contained a significant amount of solid manure in windrows (Photo 7).

Photo 7 taken 10 October 2012: Wastewater Storage Lagoon #1

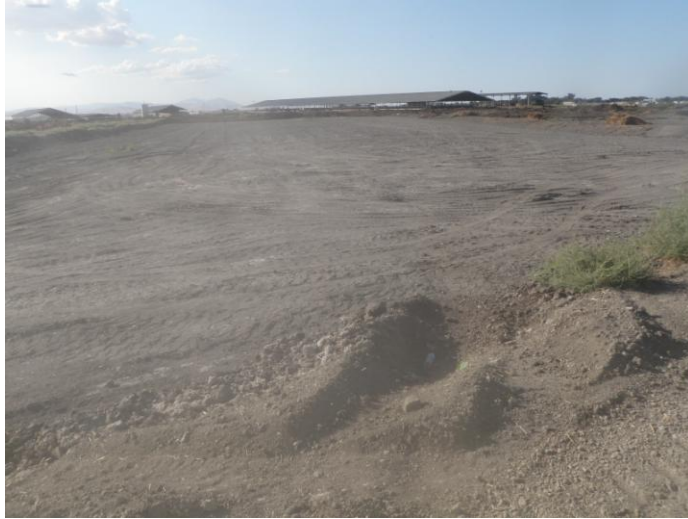
Wastewater Storage Lagoons #2 contains several small piles of dry solid manure (Photo 8)

Photo 8 taken 10 October 2012: Wastewater Storage Lagoon #2

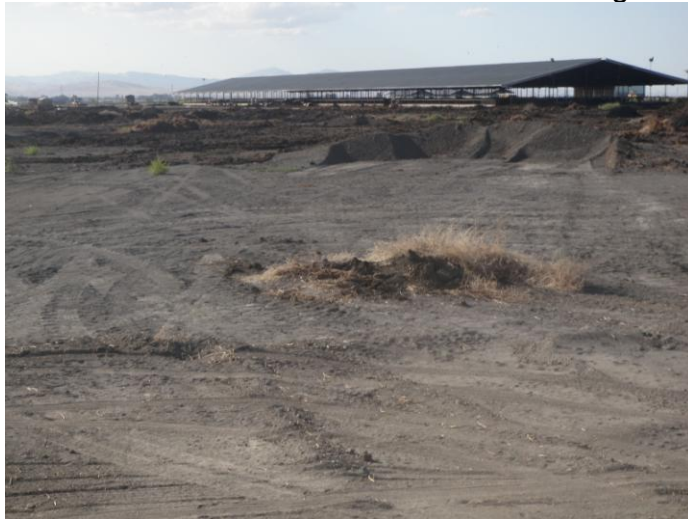
Wastewater Storage Lagoons #3 contains several small piles of dry solid manure (Photo 9).

Photo 9 taken 10 October 2012: Wastewater Storage Lagoon #3

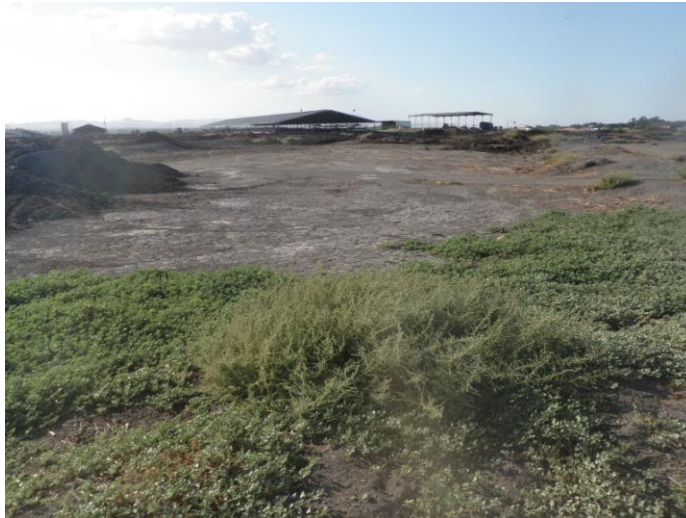
Wastewater Storage Lagoons #4 contains several small piles of dry solid manure. (Photo 10)

Photo 10 taken 10 October 2012: Wastewater Storage Lagoon #4

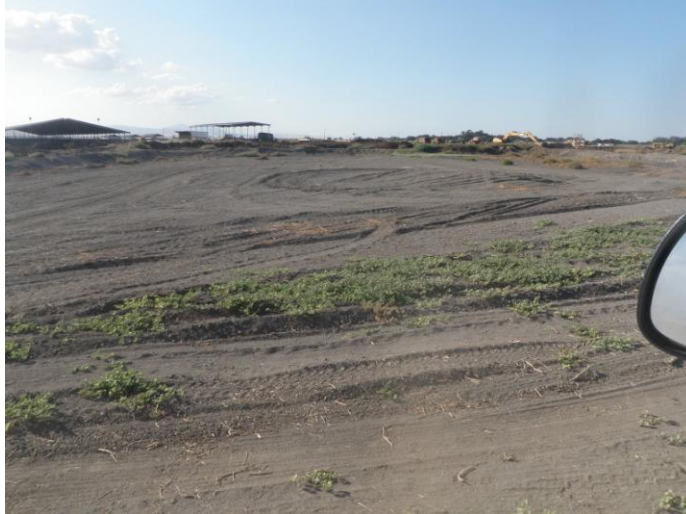
Wastewater Storage Lagoons #5 contains several small piles of dry solid manure. (Photo 11)

Photo 11 taken 10 October 2012: Wastewater Storage Lagoon #5

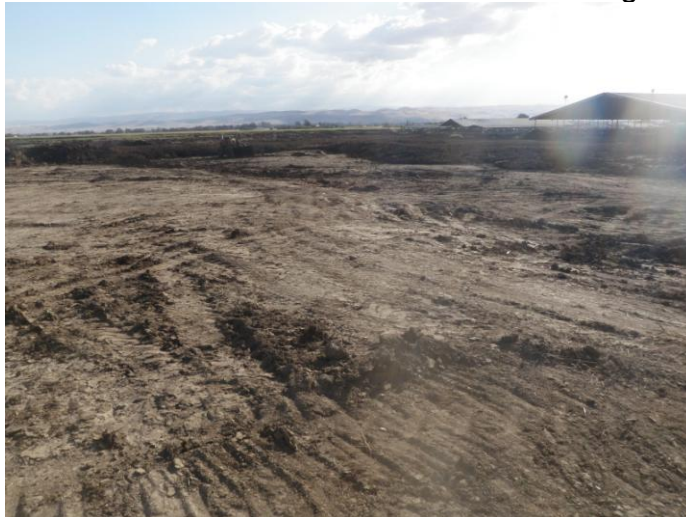
At the time of our inspection no manure was actively being staged for drying and/or removal from the 3-4 acre area of native soil. It appears at some point some of the manure in this area has been re-located to the northern end of Wastewater Storage Lagoon #3 for drying (Photo 12); but the area still contains a significant amount of solid manure, slurry manure, and wastewater (Photo 13-15).

Photo 12 taken 10 October 2012: A very small portion of manure has been moved / re-located from the 3-4 acre area of native soil that contained a significant amount of manure. It appeared to staff the manure was spread inside the northern end of Wastewater Storage Lagoon #3.

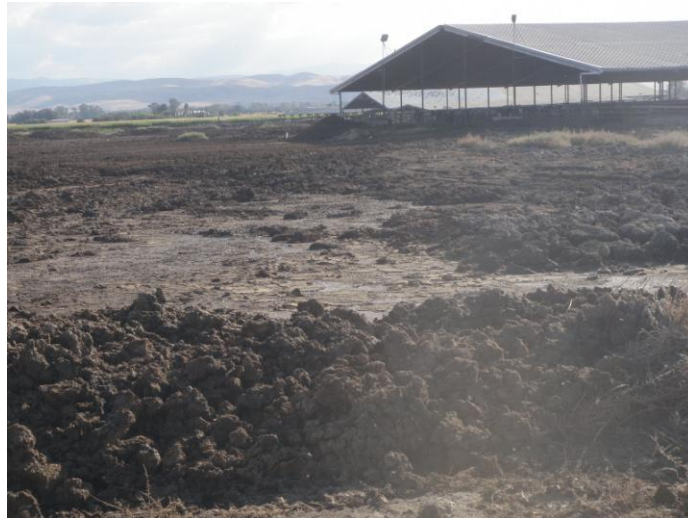
Photo 13 taken 10 October 2012: Significant amounts of solid manure, slurry manure, and wastewater still remain in the 3-4 acre area of native soil. Manure is being pushed around / relocated, but it does not appear to staff manure is being removed.

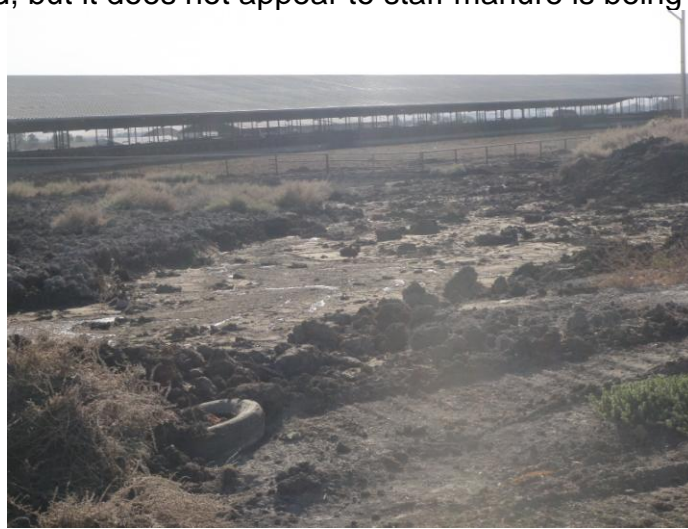
Photo 14 taken 10 October 2012: Significant amounts of solid manure, slurry manure, and wastewater still remain in the 3-4 acre area of native soil. Manure is being pushed around / relocated, but it does not appear to staff manure is being removed.

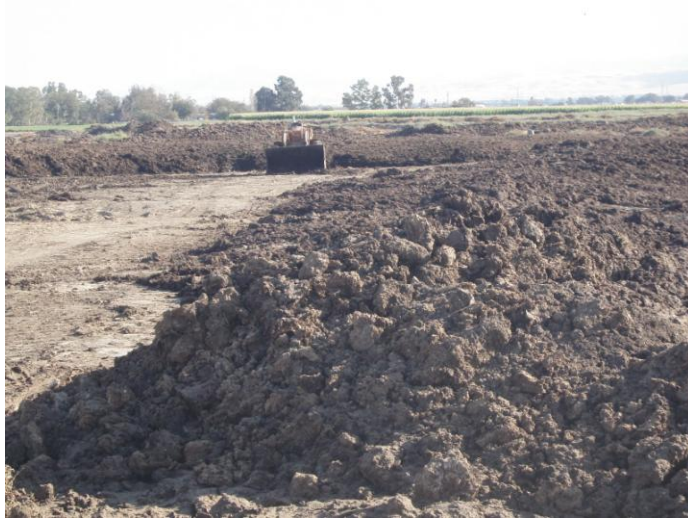
Photo 15 taken 10 October 2012: Significant amounts of solid manure, slurry manure, and wastewater still remain in the 3-4 acre area of native soil. Manure is being pushed around / relocated, but it does not appear to staff manure is being removed.
